MICHAEL B. COSMOPOULOS

# IKLAINA THE MONUMENTAL BUILDINGS

ATHENS 2018

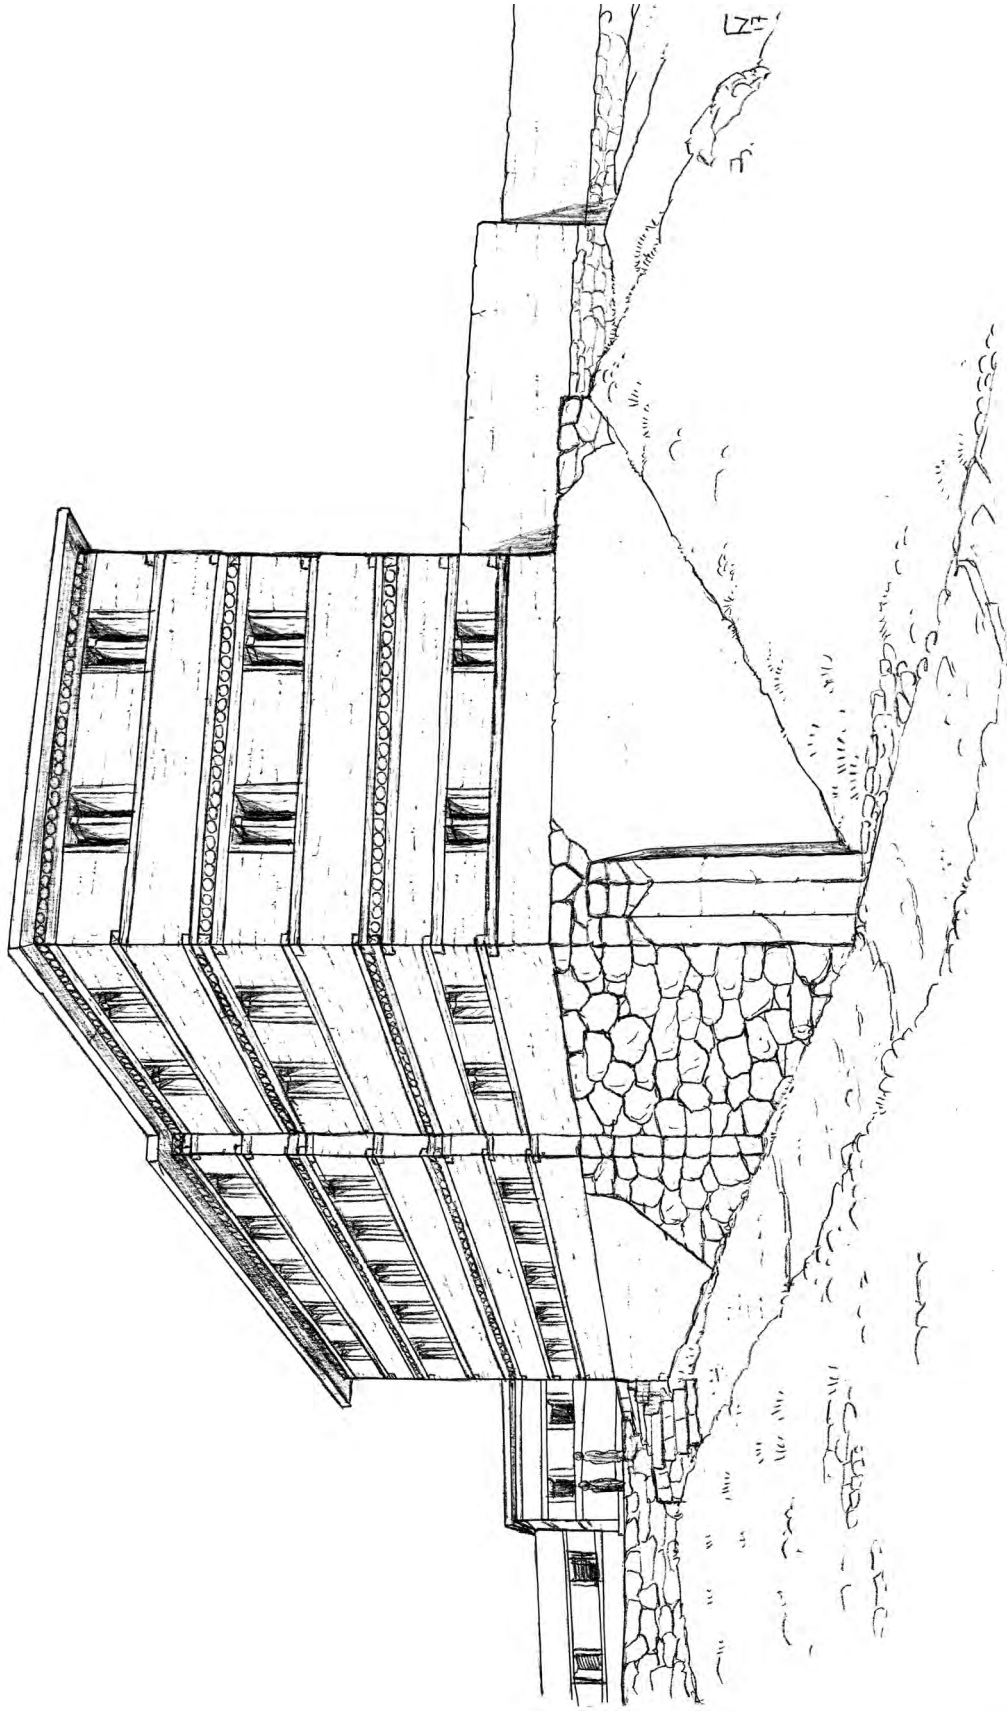
Plate IV. Artist's reconstruction of the Cyclopean Terrace Building from the Northwest (by Yannis Nakas).

*The dominant architectural feature of the site is a massive stone platform built in the Cyclopean manner. The purpose of this Cyclopean Platform was to support a two- or three-story building complex that towered over the settlement (Plate IV). Unfortunately, over the course of the centuries the Cyclopean Platform and its adjacent buildings suffered extensive damage, both by the elements of nature and the hand of man. In addition to farming and ploughing, which destroyed much of the visible architecture, a great number of worked stones from the ruined Mycenaean buildings, which lay around the surface of*

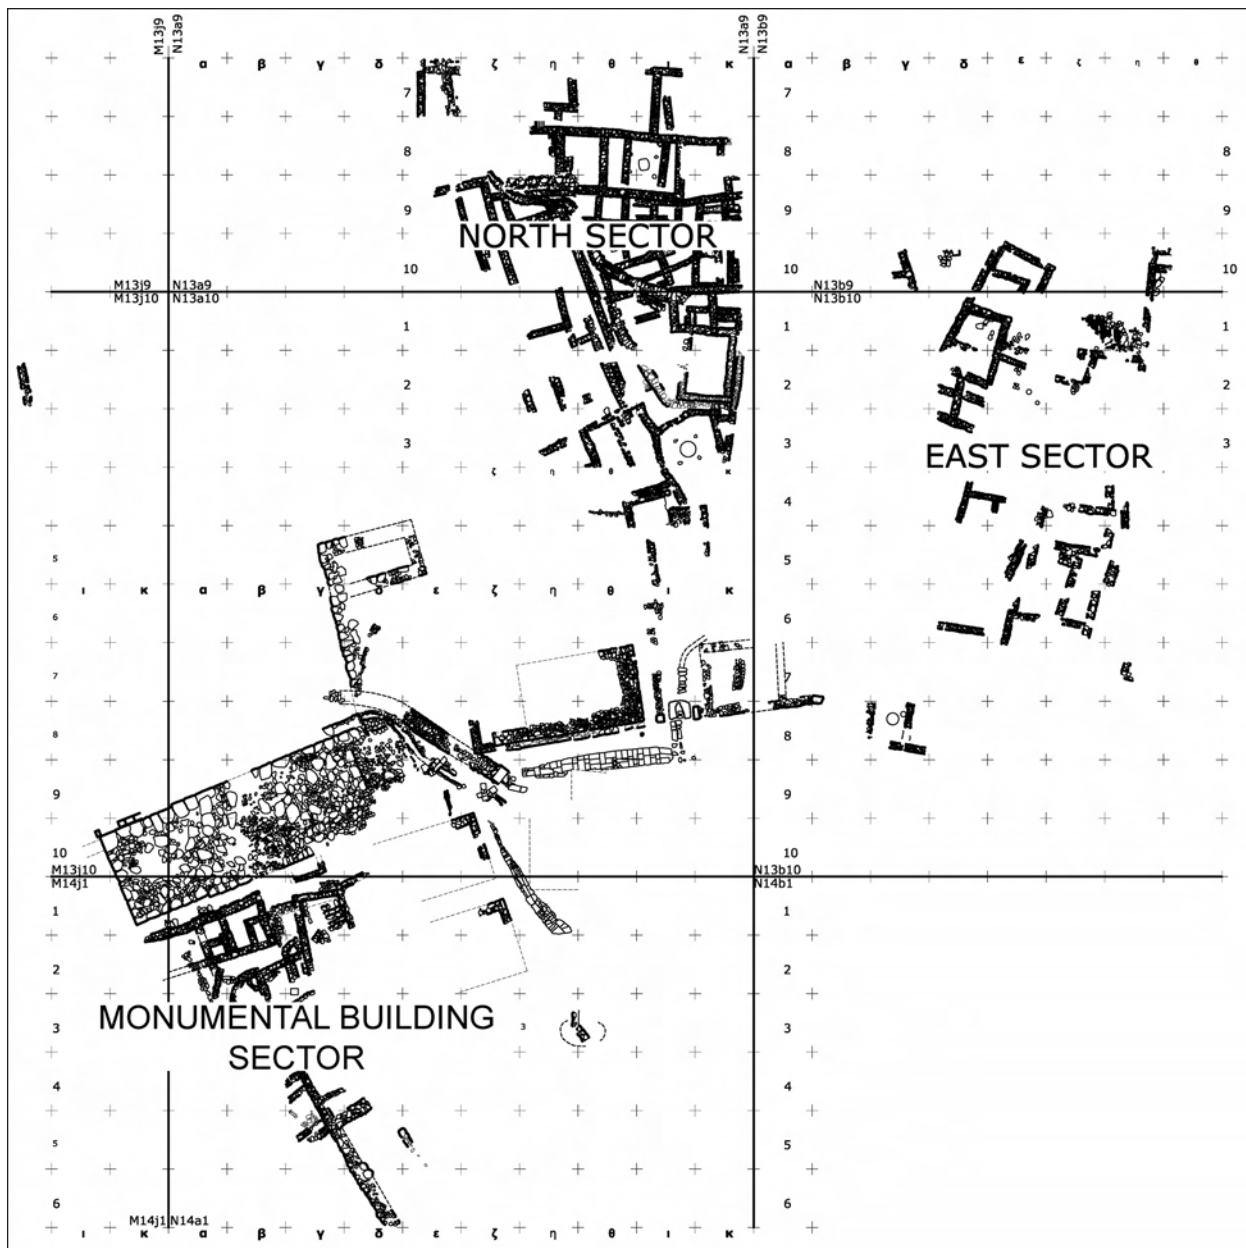
Fig. 1. Master plan of the site (end of 2016 season) showing the grid (by Michael Nelson).

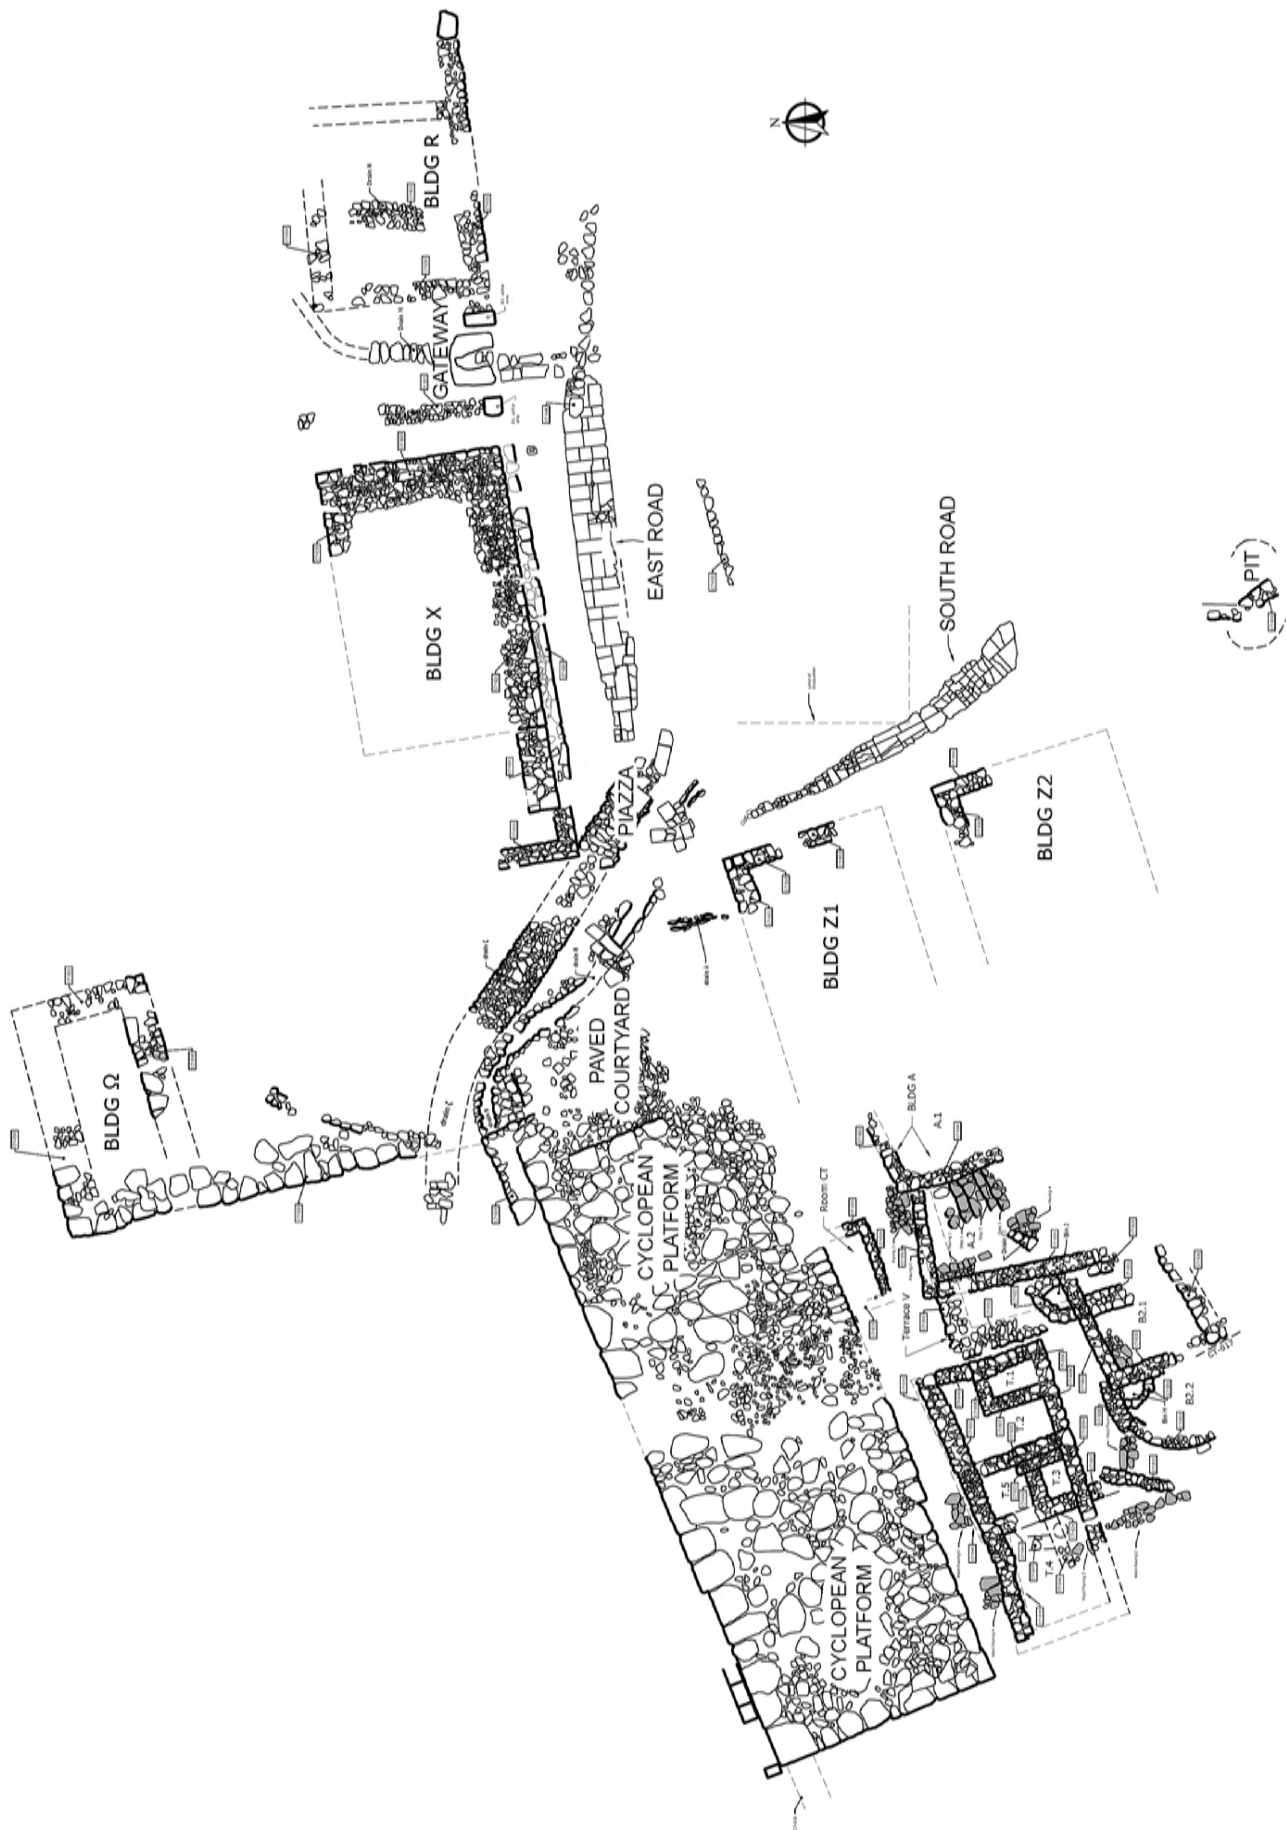
Fig. 3. General plan of the Monumental Building Sector (by Michael Nelson).

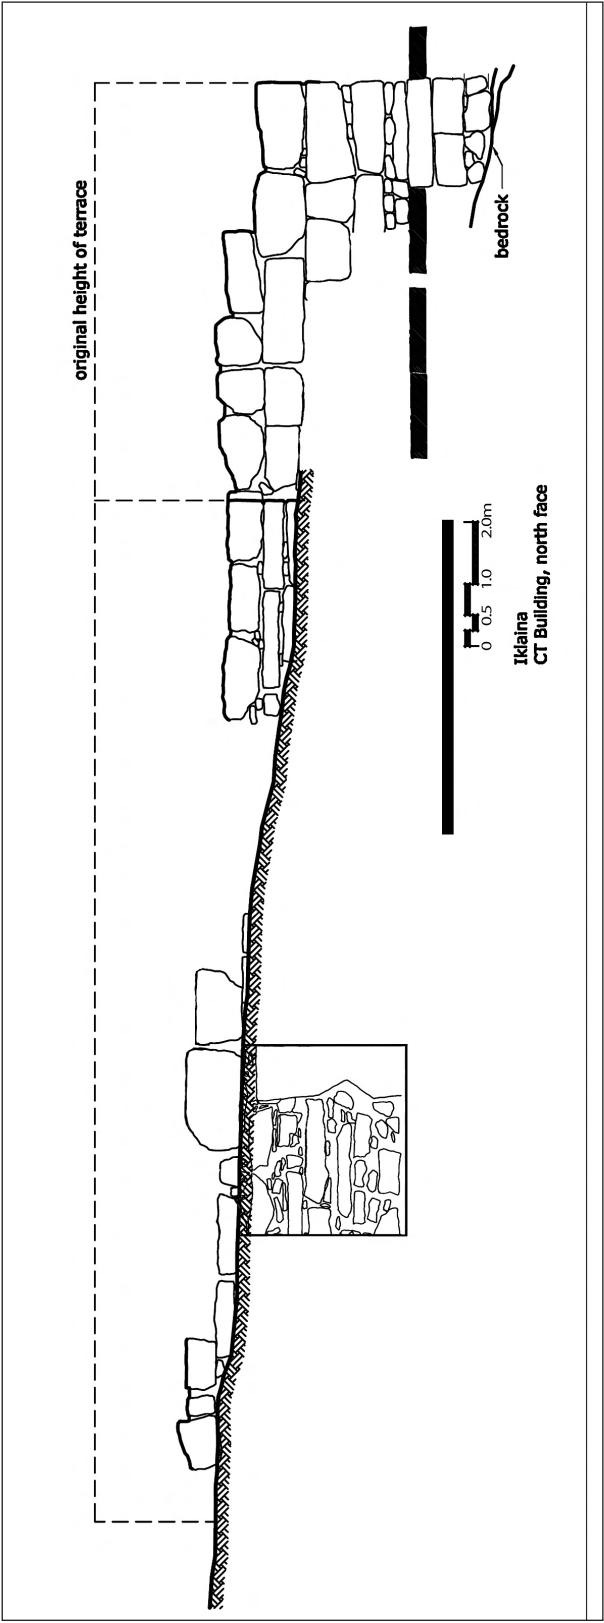
Fig. 4. Section of the north face of the Platform (by Michael Nelson).

Platform, where we identified a narrow foundation trench (pl. 22). Two indentations on the north wall and one on the south wall of the Platform articulate a corresponding number of offsets (the west indentation of the north wall is visible in pl. 5). These offsets do not serve any structural purpose: although they appear to mark different compartments of the Platform, the core behind them bonds, which suggests that they were decorative.<sup>4</sup> Fragments of white plaster with faint traces of red and blue color still adhering to the north wall of the Platform suggest that this façade was coated with a thick layer of plaster (pl. 25).

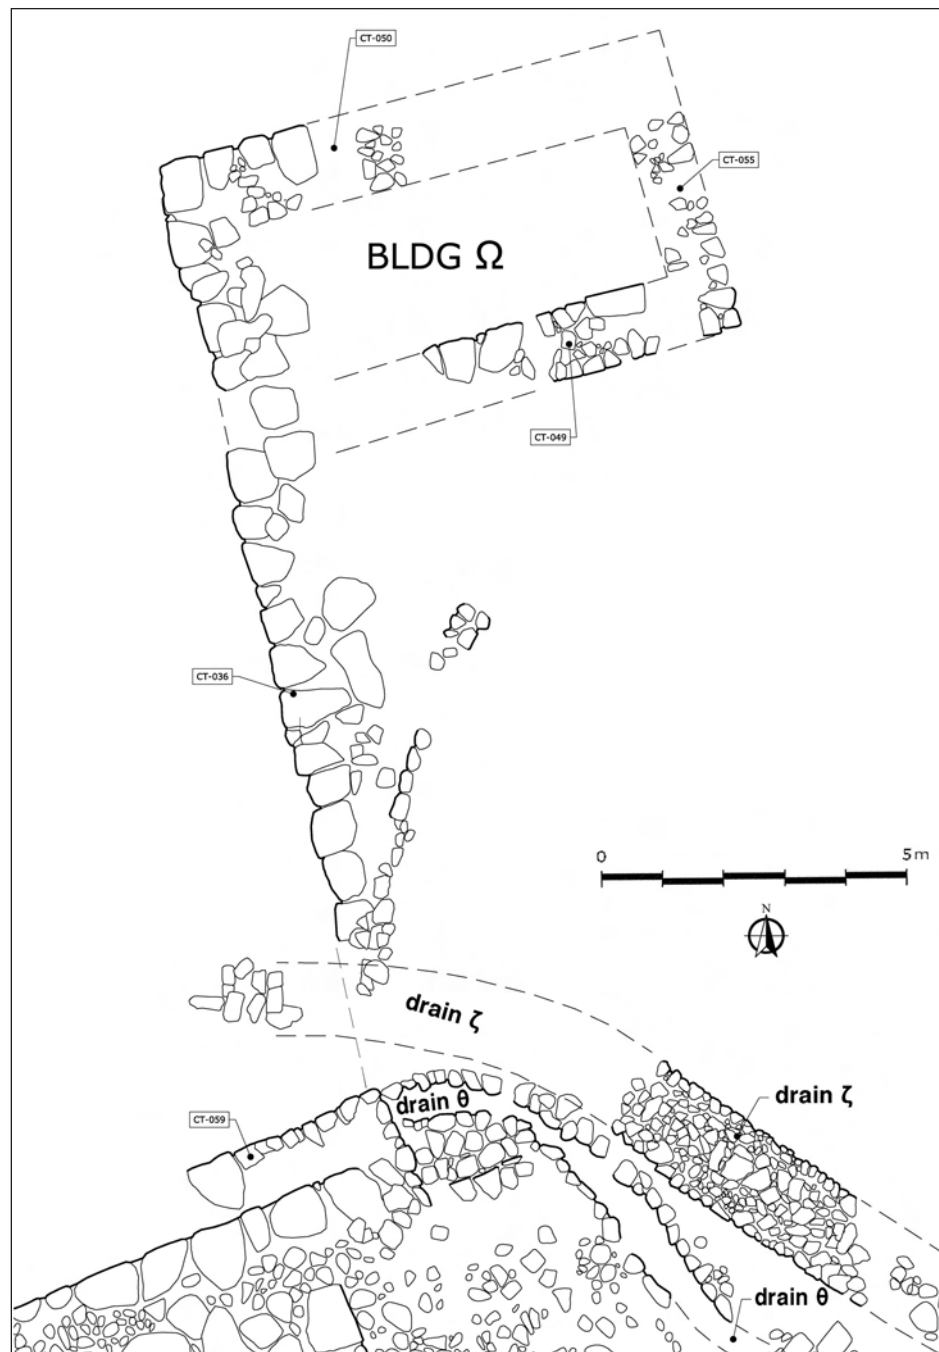
Fig. 6. Plan of wall CT-036 and rectangular space to the East.

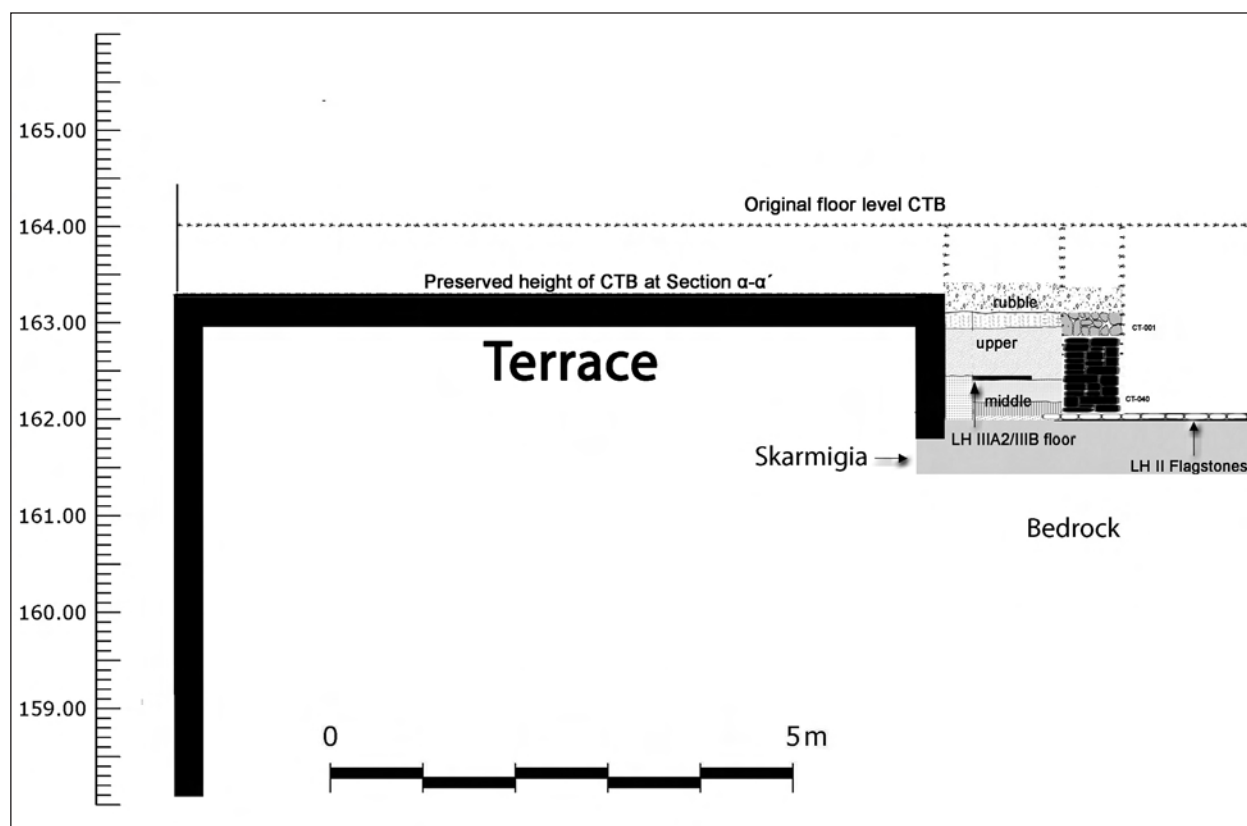
Fig. 11. Section  $\alpha\text{-}\alpha'$  in the space between the south side of the Platform and CT-001, looking East in N14a1 $\alpha$ 1. Cf. fig. 9.

The *upper* deposit (N14a1α1 L. 3) ranged in thickness from 0.318 m in the east part to 1.014 m in the sloping west part and consisted of a dark brown loose soil with a relatively high content of silt and sand, which sat on a floor made of clay and small pebbles (N14a1α1 L. 8/8a). The extent of the floor could not be surmised, because only a patch measuring 0.40×0.25 m has survived. The pottery from the surface of the floor was fairly homogeneous and consisted predominantly of fine drinking vases dated to LH IIIA2/LH IIIB (one is dated to LH IIIA2 Late). Other finds from the floor included fragments of plaster, disintegrated mudbricks, remains of carbonized wood, and animal bones.

The *lower* deposit (M14j1 $\alpha$ 1 L. 19, 20; not included in fig. 11, which shows the section in N14a1 $\alpha$ 1) had loose, brown soil and ranged in thickness from 0.05 m in the higher east

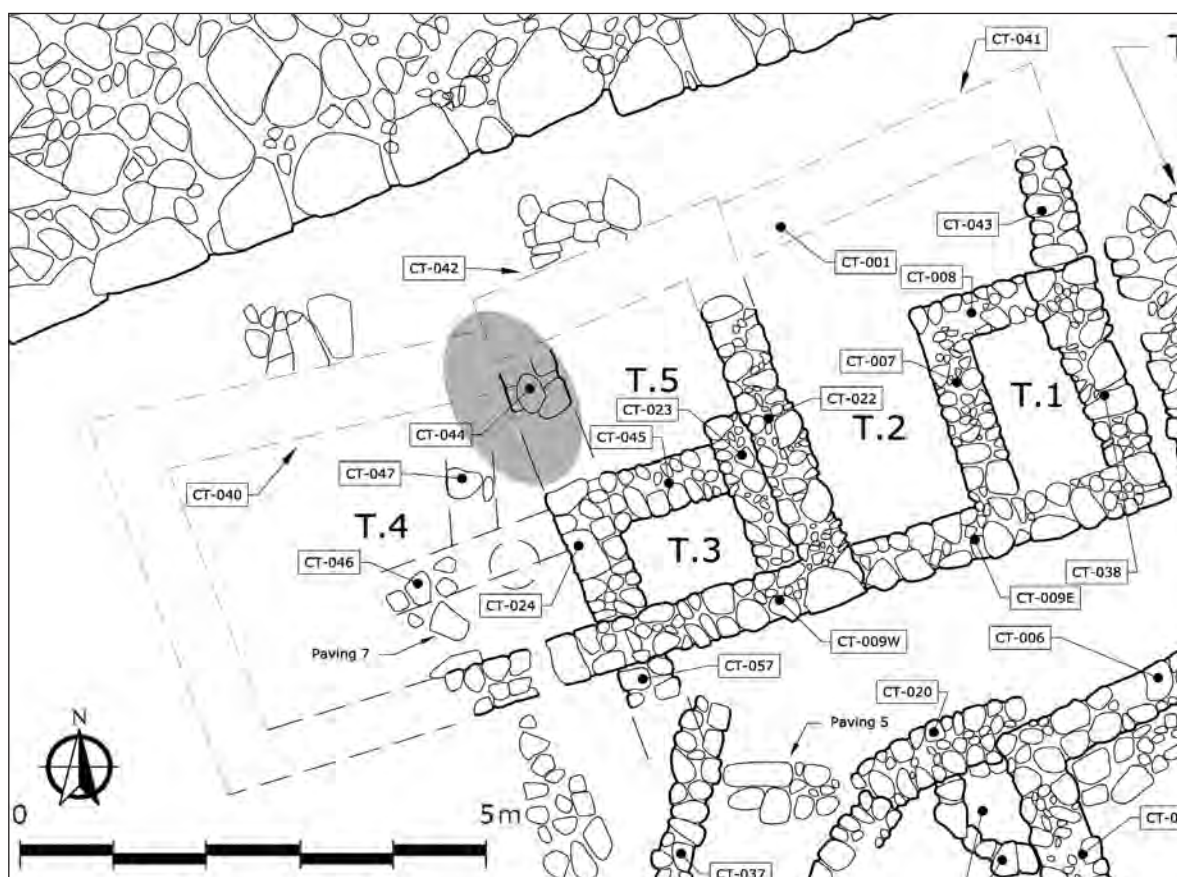
Fig. 13. Plan of Building T (by Michael Nelson), showing walls CT-040-CT-042, under wall CT-001. The shaded area indicates the pit.

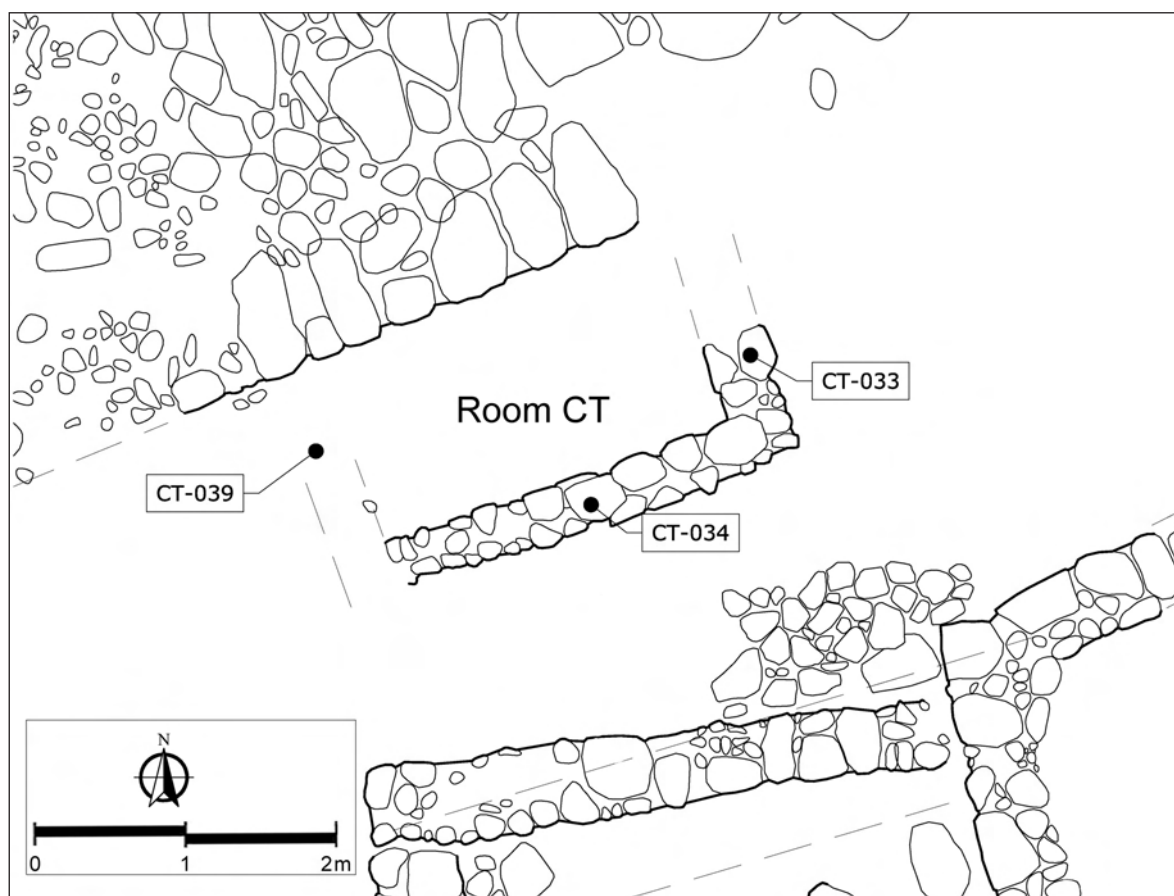
Fig. 18. Plan of the south side of the Platform showing Room CT.

A rectangular room measuring 2.30×1.30 m has been excavated on the south side of the Platform (fig. 18, pls 78, 79). To the East it is defined by wall CT-033, which runs in a North-west-Southeast direction; it is preserved to a length of ca. 0.83 m and is ca. 0.40 m wide. It runs perpendicular to the south face of the Platform, but at the point where it would have abuted the Platform the stones are missing (this spot has been heavily disturbed by the roots of an olive tree right where the wall would have joined the Platform). It is preserved to a height of two to three neatly and regularly placed courses of stones (limestone and conglomerate), with avg. dim. ca. 0.30×0.020 m. One of its blocks is a partially worked sandstone (dim. 0.50×0.30 m), perhaps used to level the wall (visible in pl. 80). It seems to have been placed directly on the *skarmigia* soil and is at a somewhat higher elevation than CT-034, probably due to the natural slope.

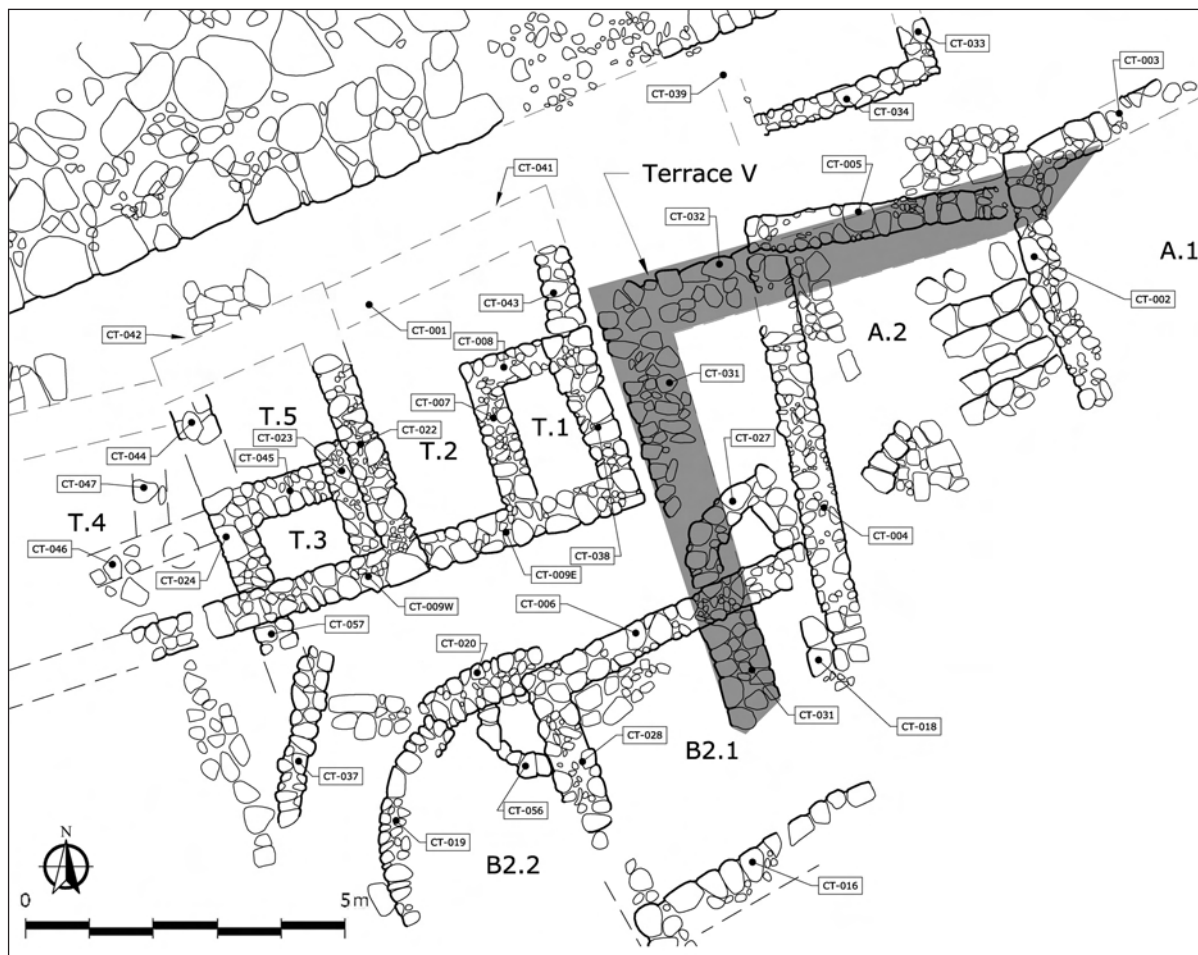
Fig. 19. Plan of the buildings to the South of the Platform. Walls CT-031 and CT-032 are greyed.

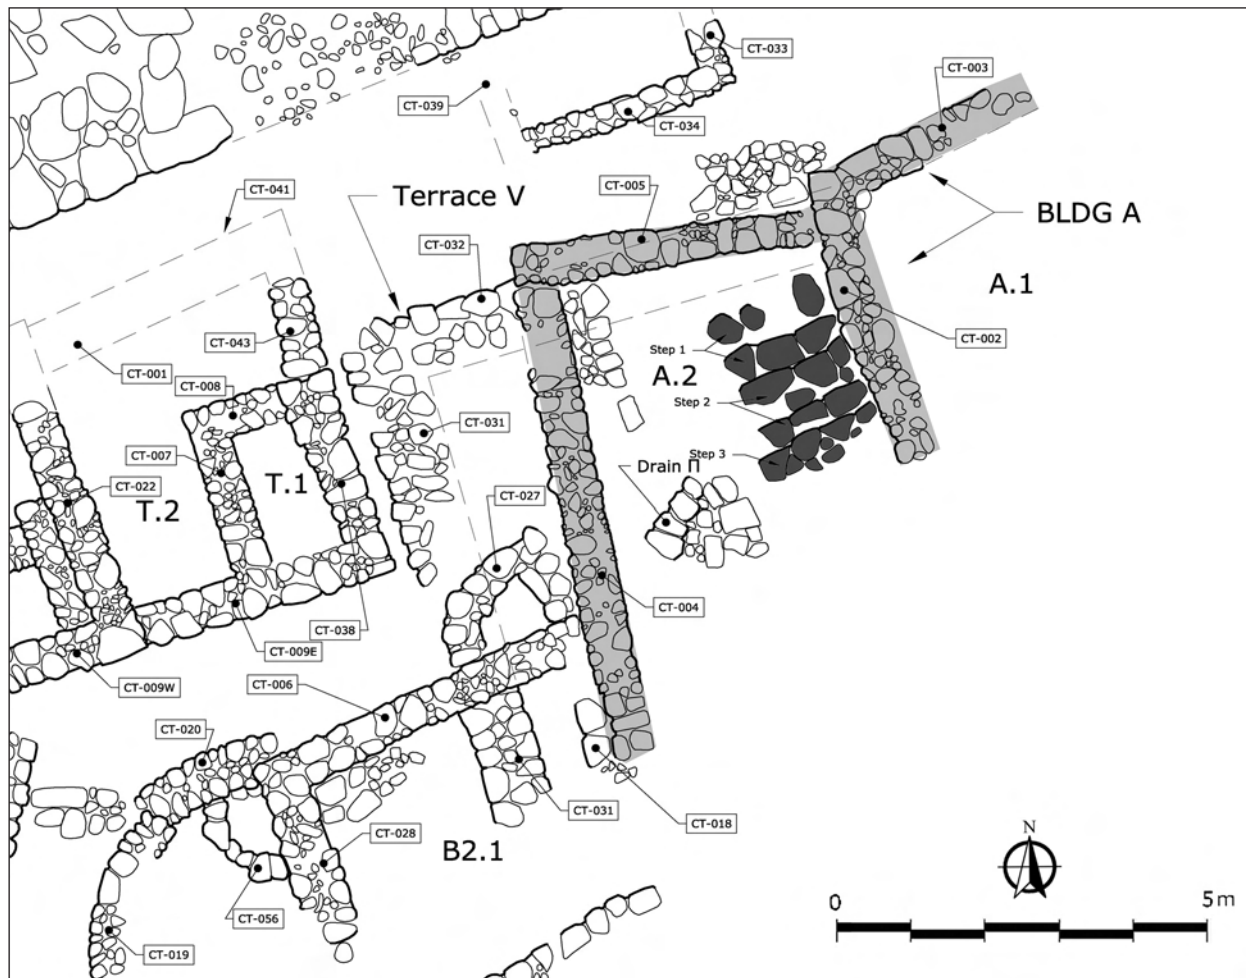
Fig. 22. Plan of Building A and the stepped ramp.

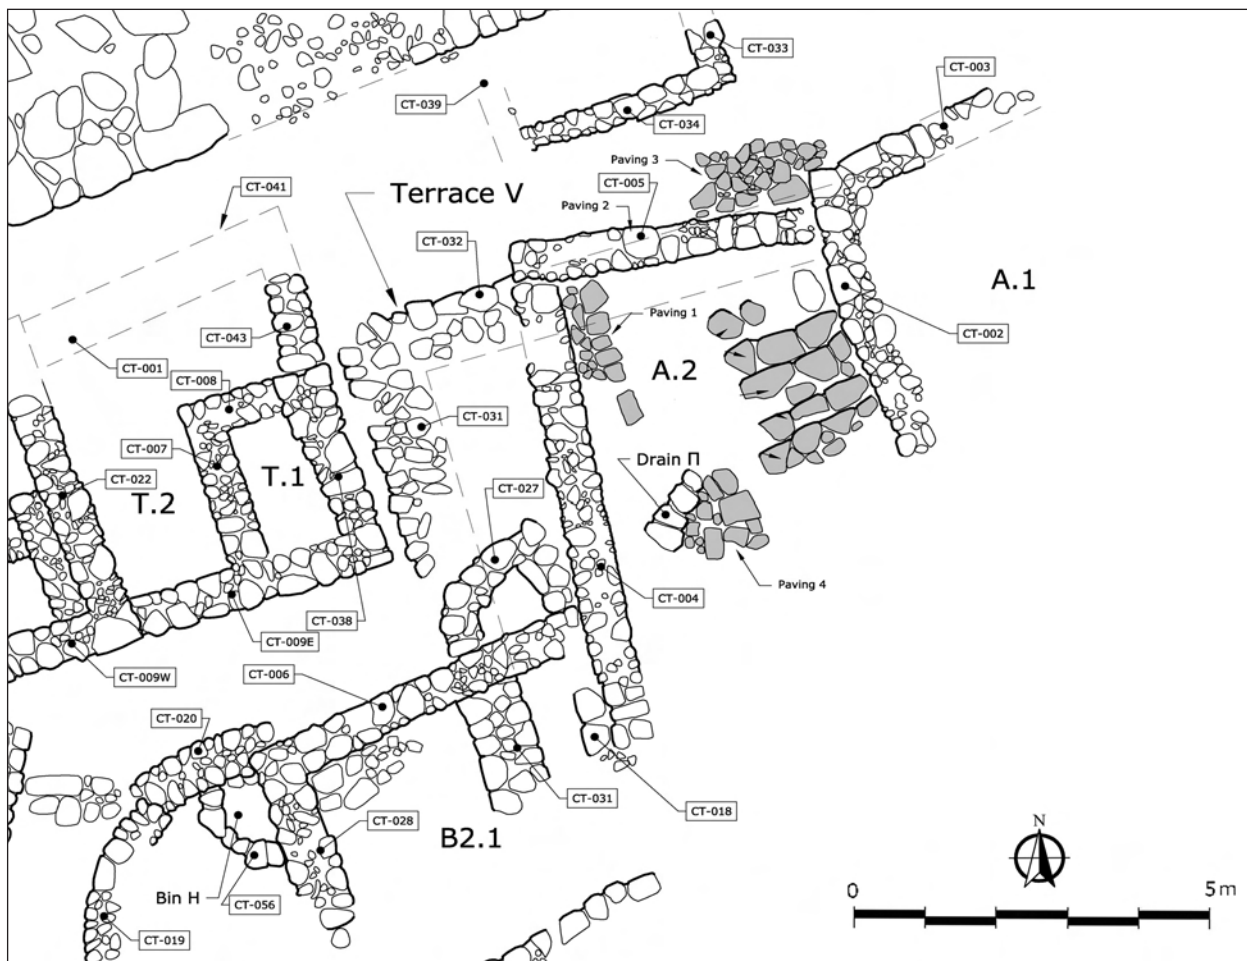
Fig. 23. Plan of Building A showing the paved features.

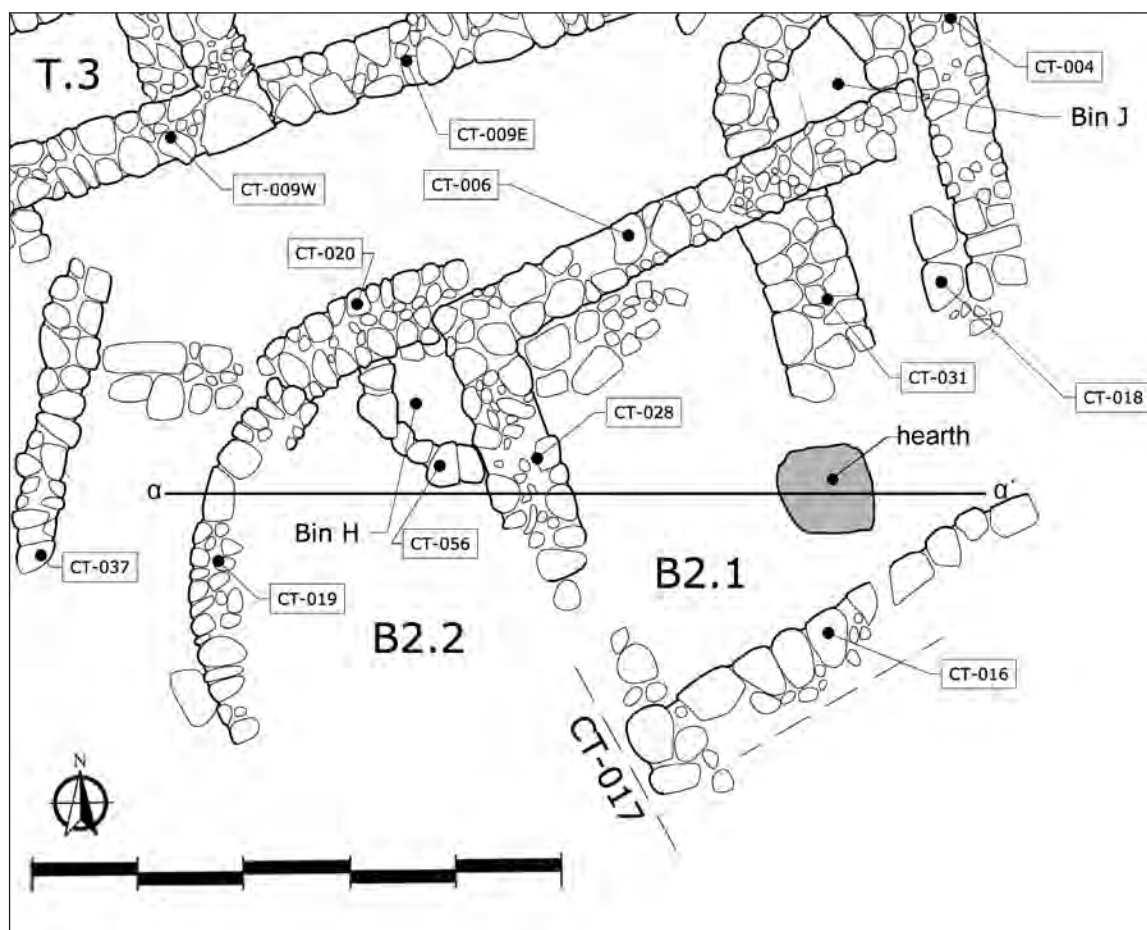
Fig. 26. Plan of Building B2. For the section  $\alpha$ - $\alpha'$  see fig. 27.

Between Buildings T and B2 there is a narrow space that extends from Terrace V in the East to the edge of Building T in the West (fig. 26). Its length cannot be determined because its west end has not been preserved, but its width is 1.50-1.80 m. In the east part it does not include any architectural features, but the excavated deposits provided useful informa-

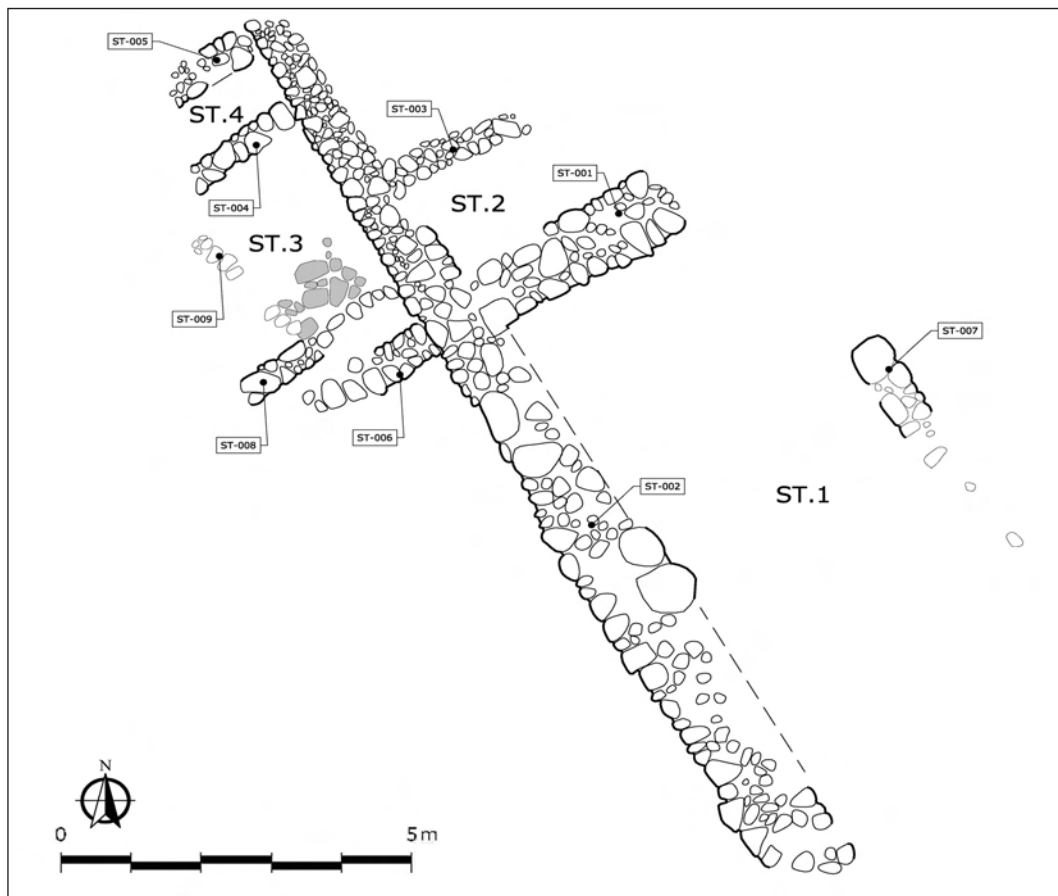
*Fig. 30. Plan of the South Terrace Building.*

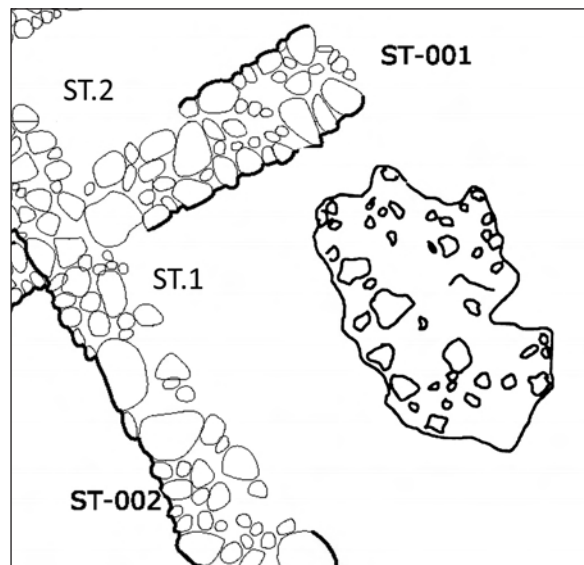
*Fig. 31. Plan of the pit in space ST.1.*

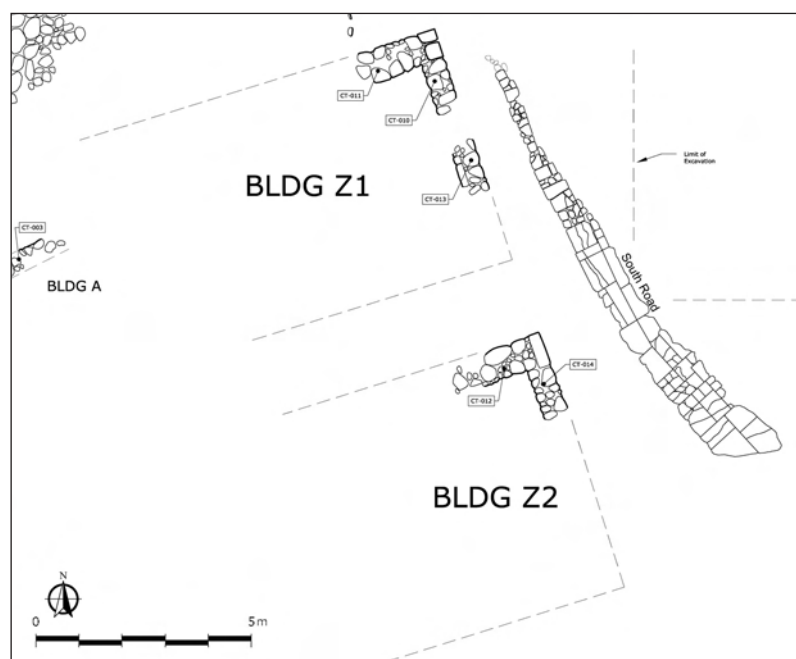
Fig. 33. Plan of Buildings Z1 and Z2.

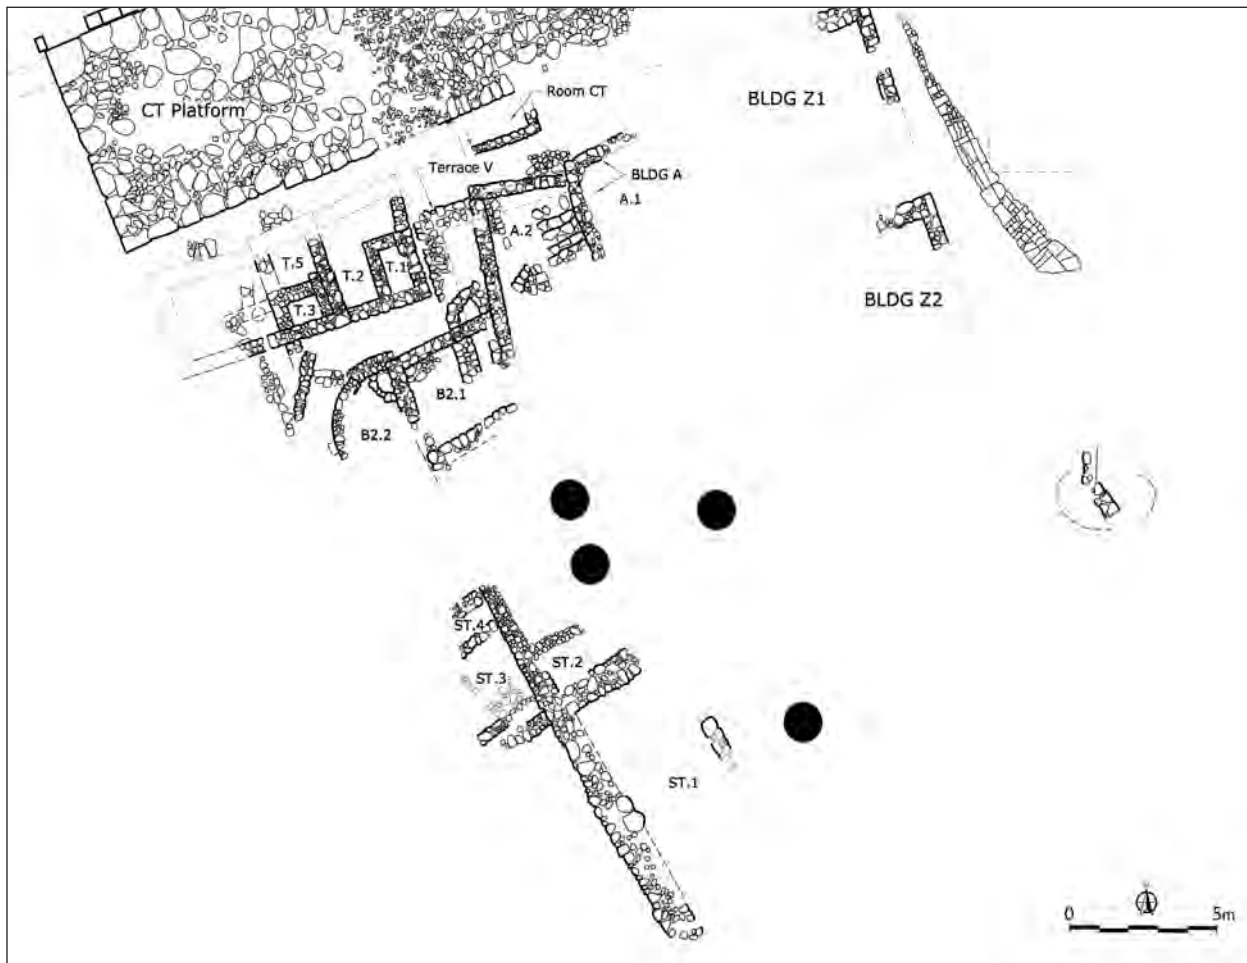
Fig. 35. Plan of the area to the South of the Platform; the circles indicate the spots with remains of the courtyard floor.

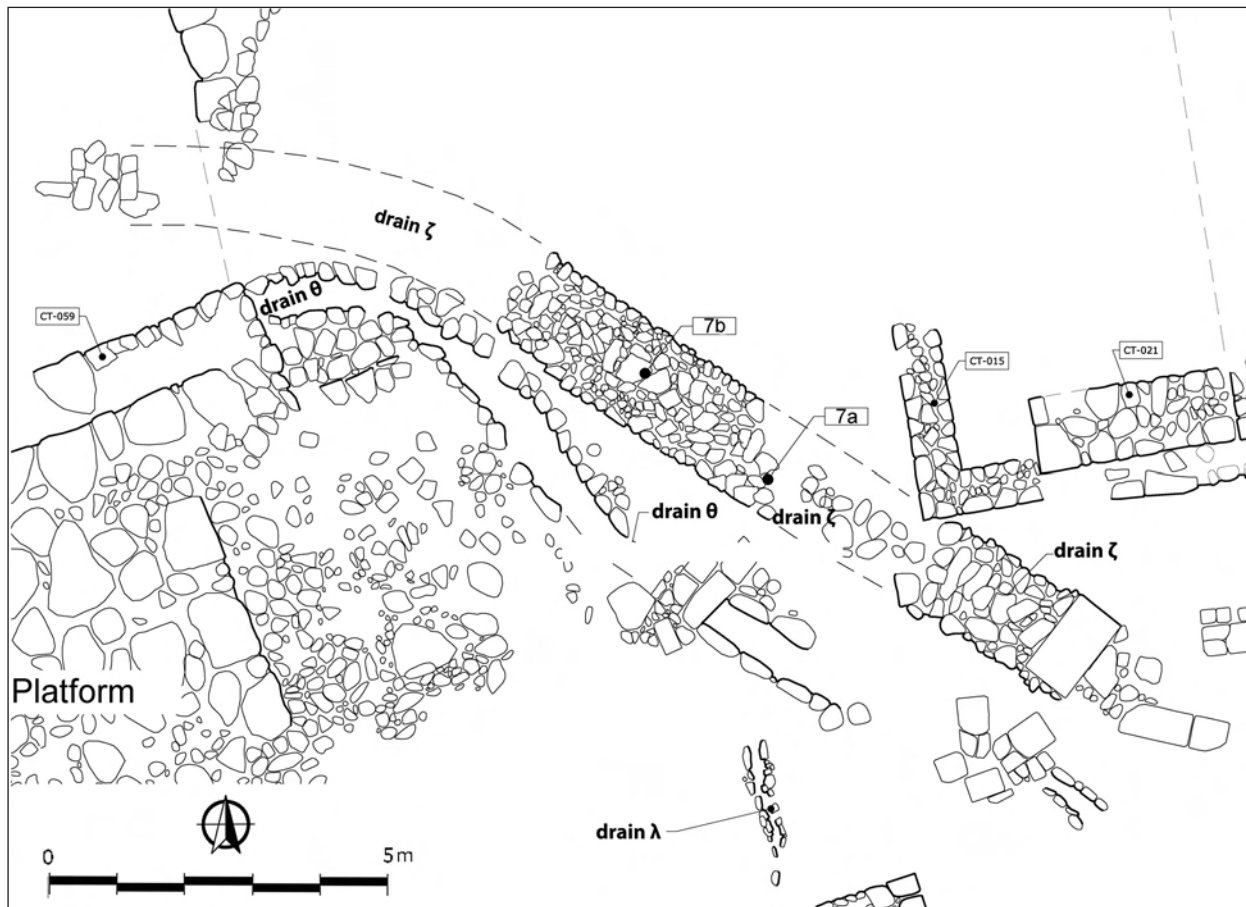
*Fig. 36. Plan of drains  $\theta$  and  $\zeta$ .*

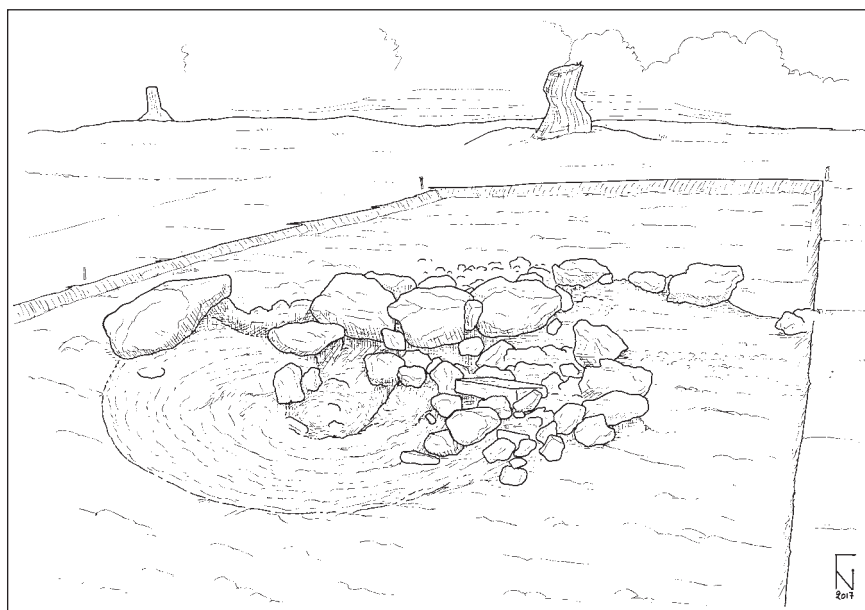
Fig. 39. Drawing of the Pit from the East (by Yannis Nakas).

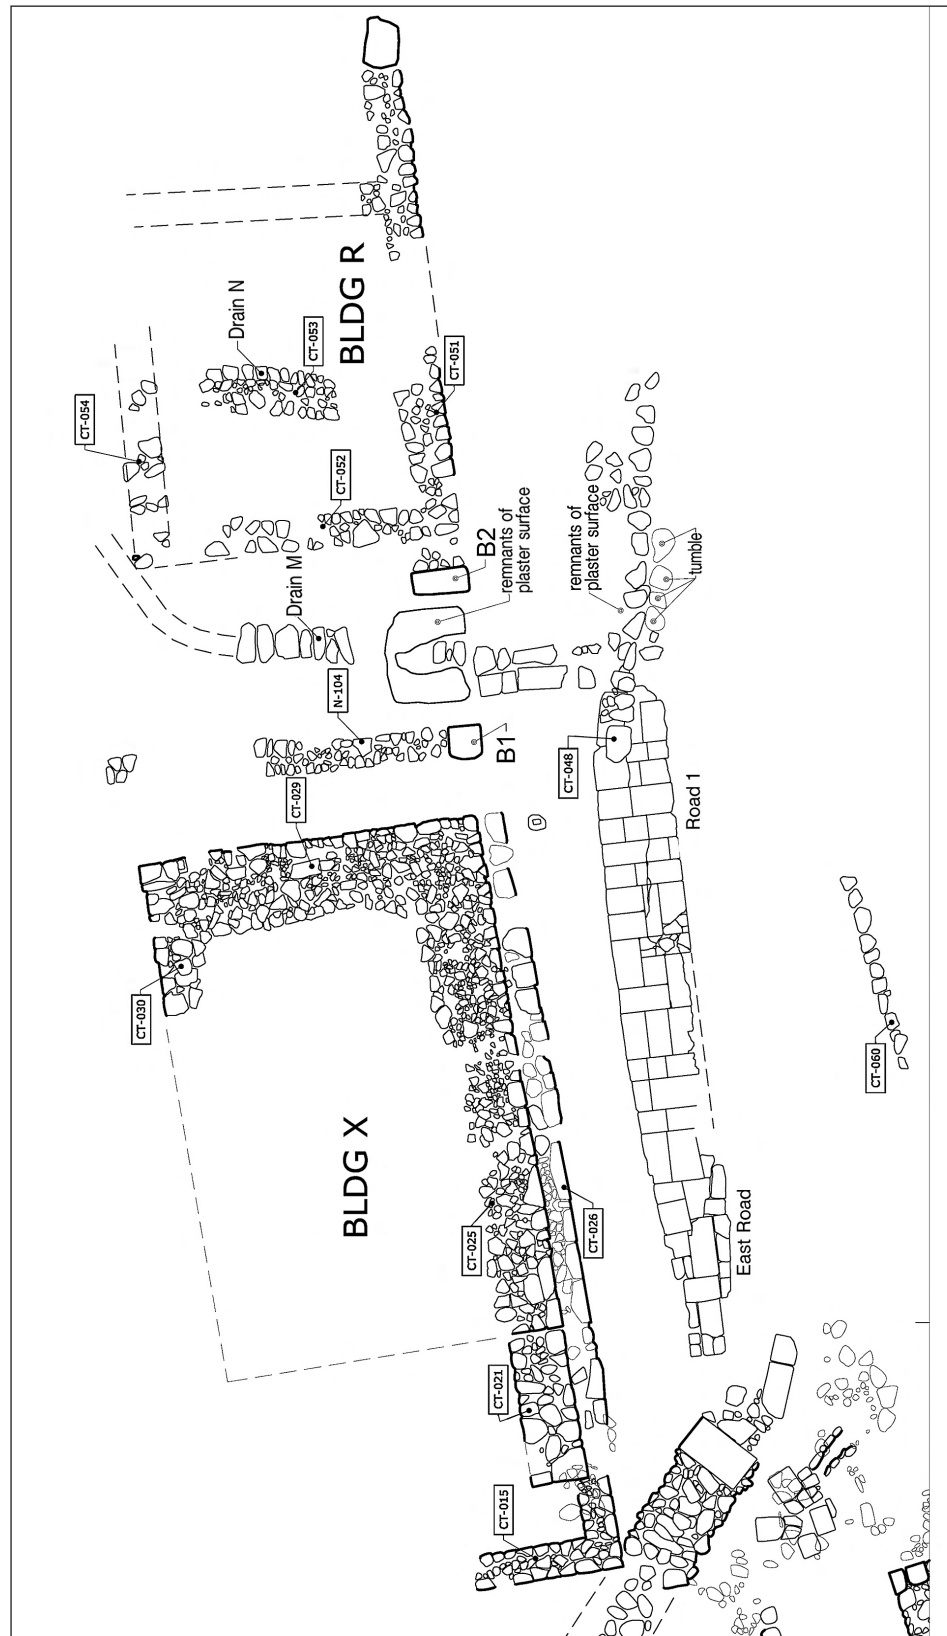
Fig. 45. Plan of Building X and adjacent structures.
