MICHAEL B. COSMOPOULOS

# IKLAINA THE MONUMENTAL BUILDINGS

ATHENS 2018

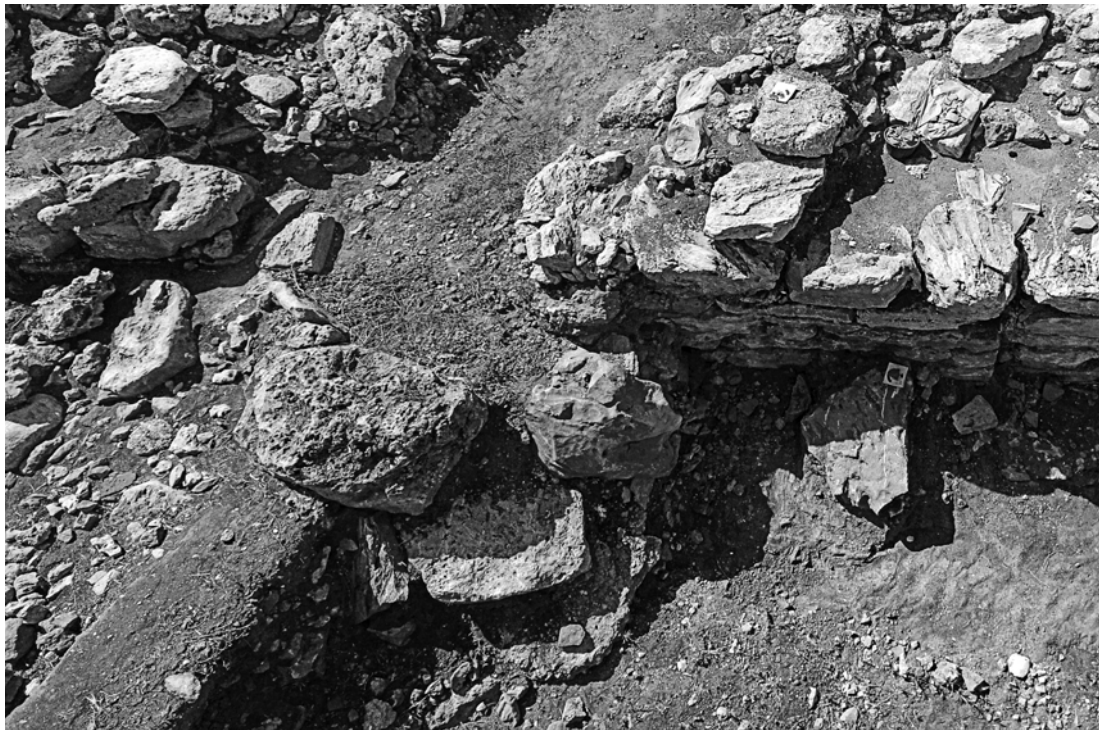
*Pl. 4. Aerial view of the mid-section of the Platform, showing the spill of Cyclopean blocks.*

In the middle part of the Platform the opening caused by the bulldozer is blocked by three large Cyclopean blocks that have fallen in front of the structure (indicated by the arrow in pl. 3 and clearly visible in pl. 4). Although these blocks will eventually be restored to the monument, at the time of the excavation they were left in place.

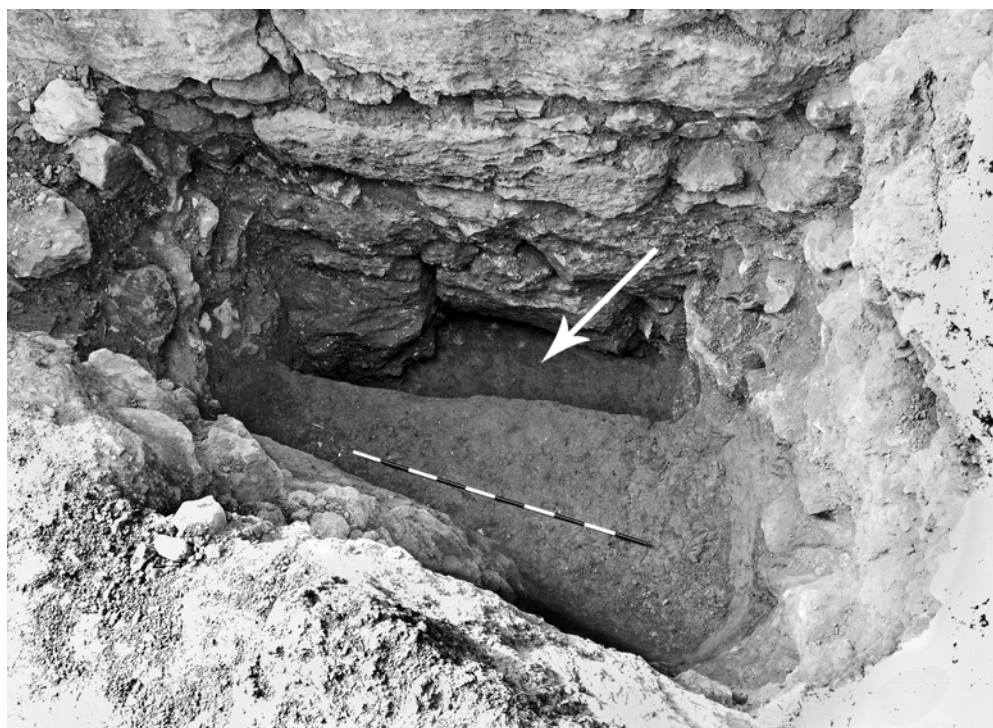
*Pl. 22. View of N13a10β8 Locus 21. The arrow shows the foundation trench.*

Platform, where we identified a narrow foundation trench (pl. 22). Two indentations on the north wall and one on the south wall of the Platform articulate a corresponding number of offsets (the west indentation of the north wall is visible in pl. 5). These offsets do not serve any structural purpose: although they appear to mark different compartments of the Platform, the core behind them bonds, which suggests that they were decorative.<sup>4</sup> Fragments of white plaster with faint traces of red and blue color still adhering to the north wall of the Platform suggest that this façade was coated with a thick layer of plaster (pl. 25).

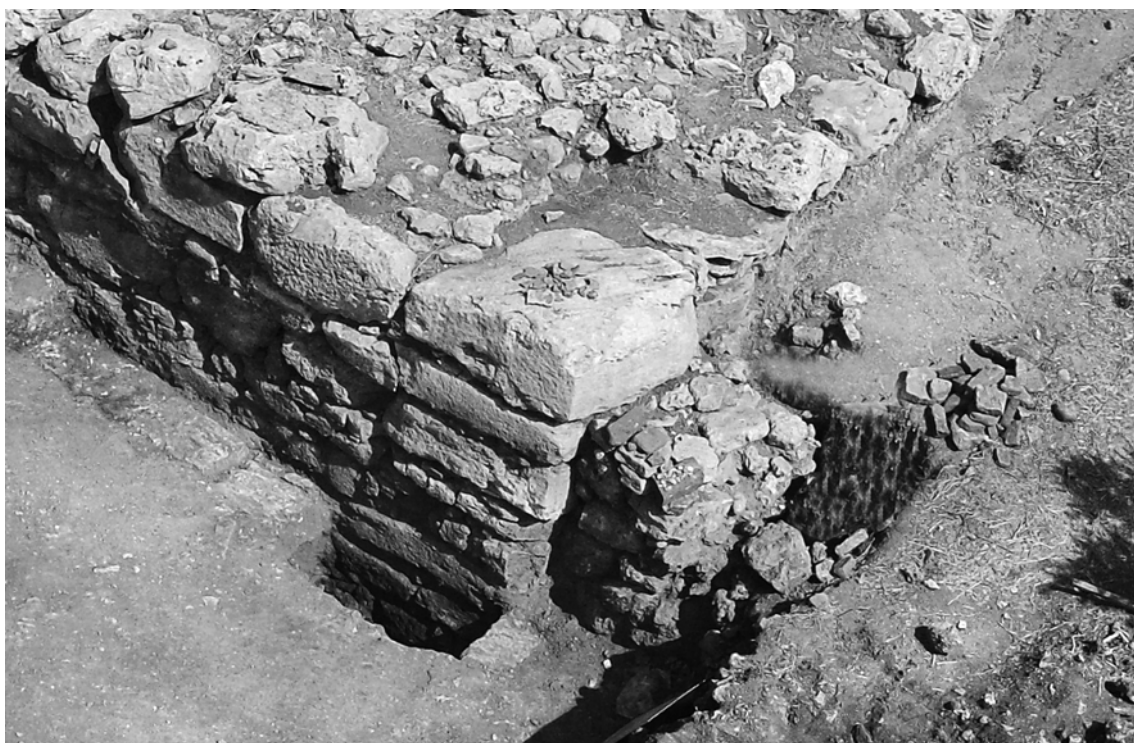
*Pl. 29. View of the northwest corner of the Platform from the Northwest, showing wall CT-058.*

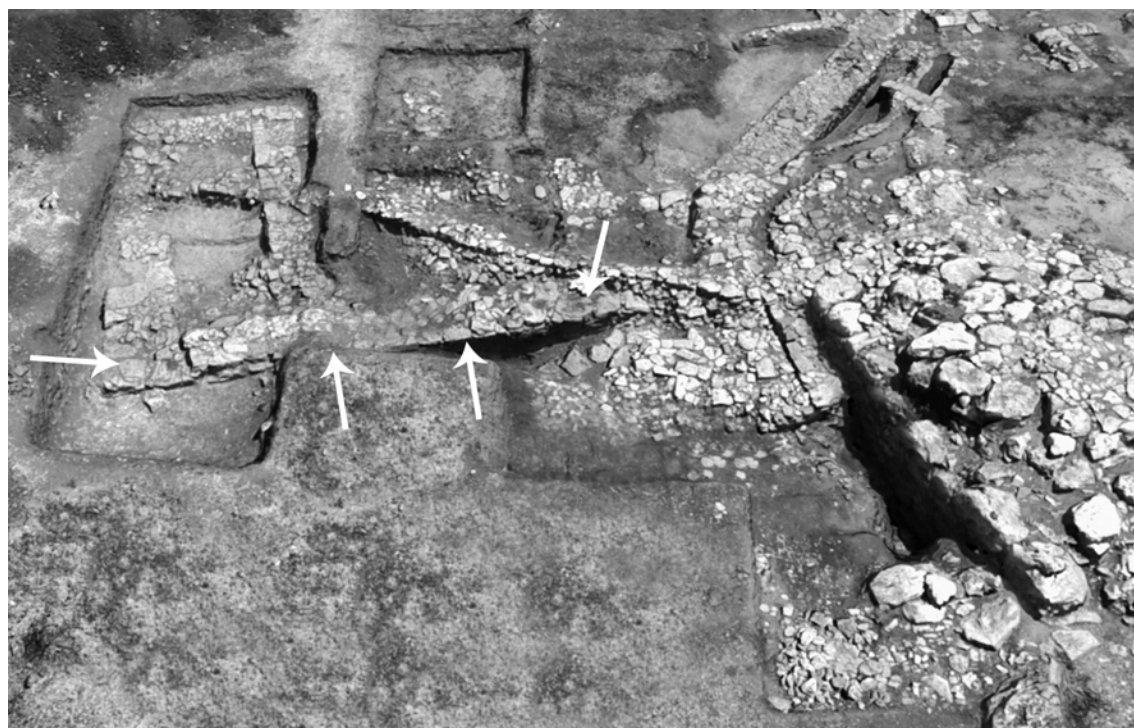
*Pl. 30. Aerial view of wall CT-036 (marked by arrows) from the West.*

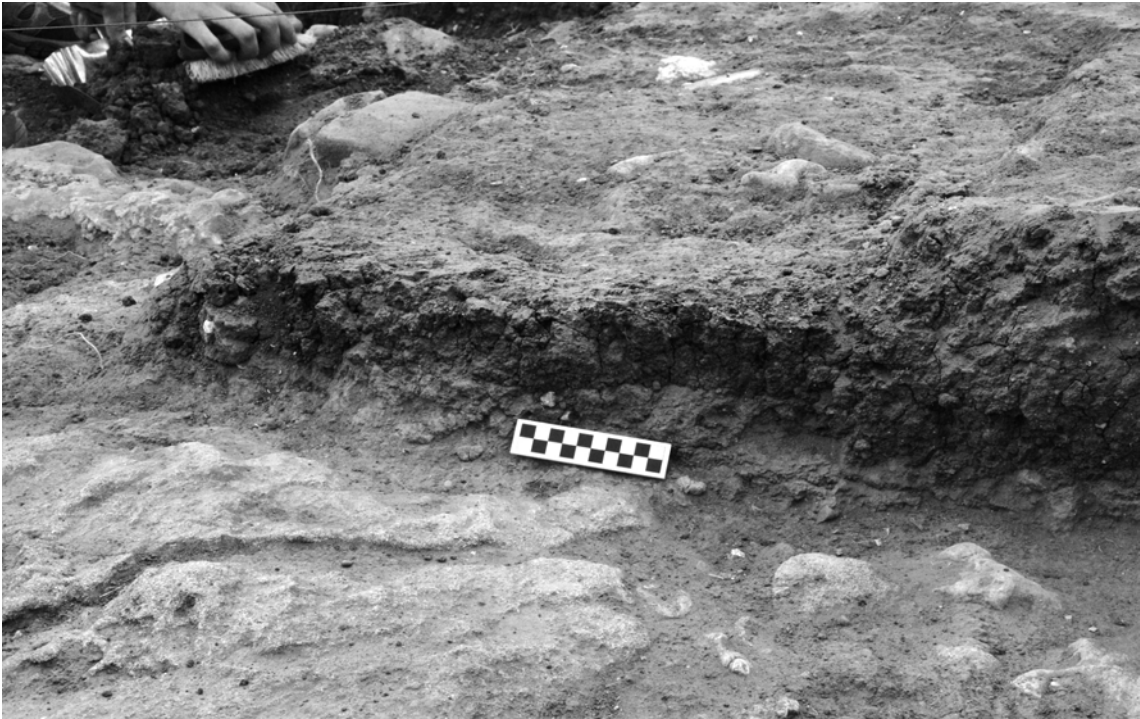
*Pl. 31. View of the sheet-like layers of charcoal and mudbrick on top of CT-036 from the East.*

The deposits associated with CT-036 contained heavy concentrations of disintegrated mudbrick mixed with a thick (0.80 m) layer of rubble, which appears to represent destruction debris from the structure that would have stood on top of the wall. This rubble was exposed in N13a10γ5 L. 5, 9, 10 and includes reddish silty soil, patches of which are burned, containing a dense layer of small (0.04×0.04 m) and large (0.40×0.40 m) stones and pieces of burned plaster and carbonized wood. In general, the larger stones are found in the eastern part of the trench near CT-036, whereas the smaller ones are concentrated in the western part of the trench further away, perhaps suggesting that the upper part of Building Ω was constructed with smaller stones (which were thrown further when the structure collapsed), whereas the lower courses were made of larger stones (which fell closer to the wall). A small trial trench on the east side of wall CT-036 (N13a10γ5 L. 11, 12) revealed that the rubble spreads also on the east side of the wall.

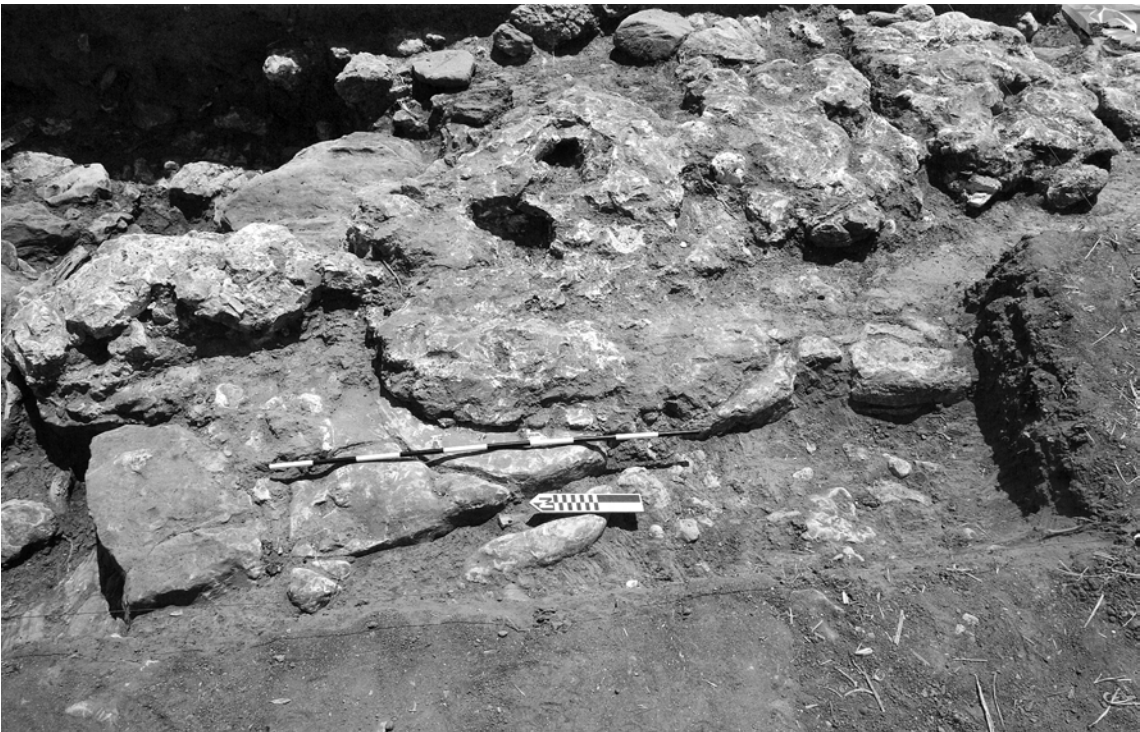
*Pl. 32. View of the north end of CT-036 with the boulders.*

is ca. 1.40 m. It is constructed with both large and smaller stones (the largest ones measure ca. 0.90×0.70 m and the smallest ones ca. 0.20×0.10 m). For most of its length it is made with eight to ten courses; the lowest courses are constructed with the largest stones as a foundation. The west face of the wall presents a smooth façade, the east face is rough, and its top surviving surface is flat. The south part, in N13a10γ7, was covered just by the topsoil, but in the north it was covered by a layer of melted mudbrick with pieces of painted plaster (N13a10γ6 L. 4). This layer overlay a sheet-like layer of carbonized wood and mudbrick (N13a10δ6 L. 17), approximately 0.40 m wide and 0.05 m thick (pl. 31). The north end of this layer in N13a10γ6 L. 5 and N13a10δ6 L. 3, 8, 10, 15 was defined by three massive irregular and heavily eroded limestone blocks with an average length of 0.80 m, placed on top of the upper surface of the wall (pl. 32).

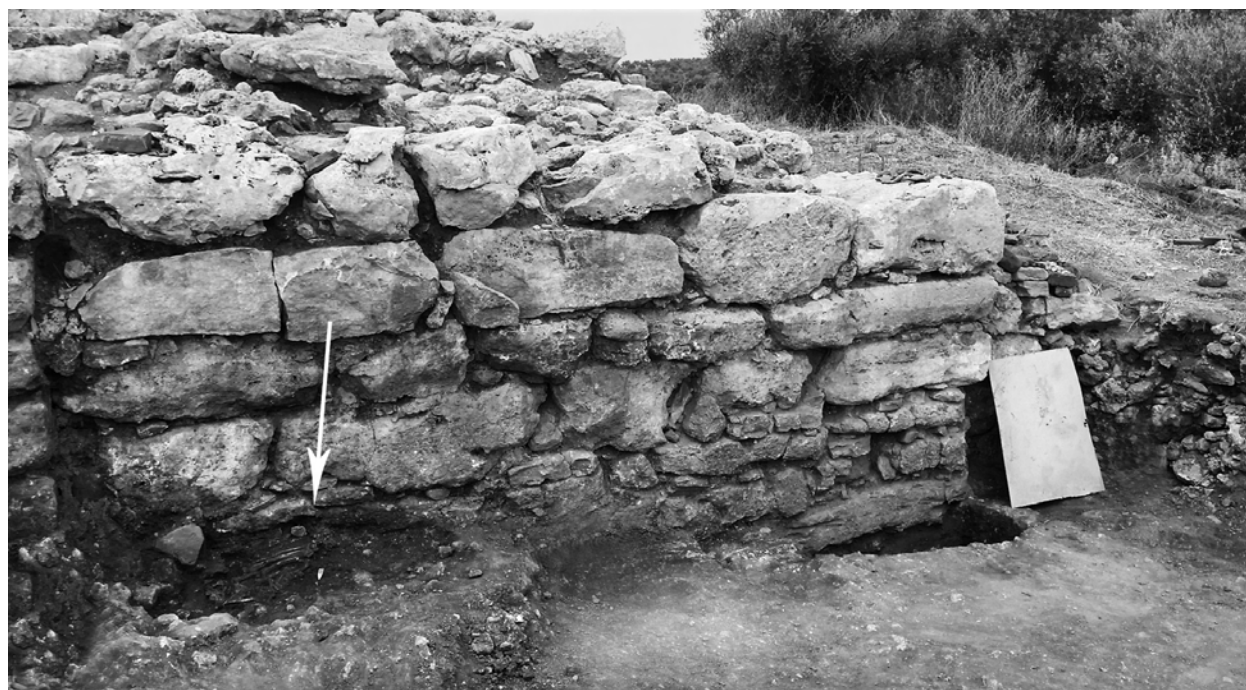
Pl. 38. View of the north façade of the Cyclopean Platform. The arrow shows the spot with the burial.

In the east end of the excavated area at a distance of 1.80 m from the northwest corner and a depth of 1.60 m from the top surviving block was found a female burial (M13j10x9, L. 2, 3, 8). The skeleton had been placed in a small pit opened inside the destruction layer and was covered with cobbles. When the modern rubble was deposited there, a large block was pushed onto the grave, smashing the soft bones. A line of small stones that seems to border the skeleton is simply the edge of the original destruction layer. The burial was covered by the rubble and pushed against the north façade of the Platform (fig. 8, pl. 38, 39). It belongs to a middle-aged woman resting on her right side, with her body oriented East-West. Some of the bones were broken, apparently as a result of the bulldozer pushing the rubble against the north wall of the Platform. Immediately on top of the body had been placed a young goat, a neonate puppy, and a bird. On the basis of the presence of the young goat and the neonate puppy, it appears that the burial occurred in early summer. Although the burial was not associated with any diagnostic pottery or burial gifts, <sup>14</sup>C analyses of a sample from the skeleton showed a calibrated date range of 779-540 BC.

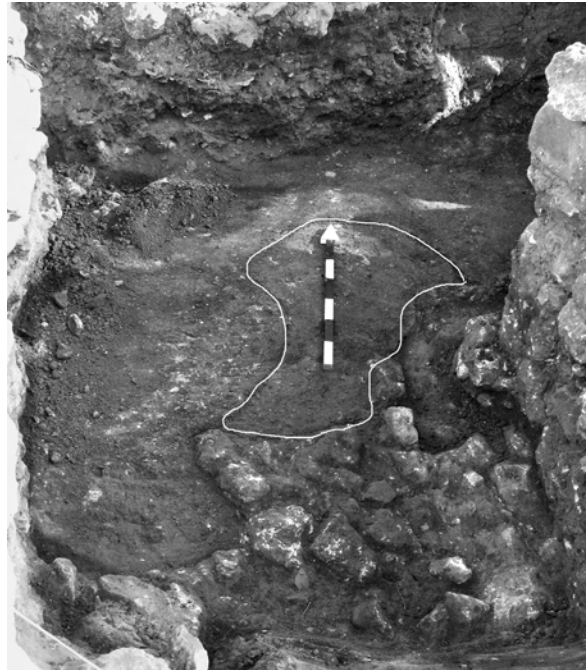
*Pl. 63. Room T2. The white line marks the outline of the burn area from a possible burned beam at the corner of CT-007 and CT-008.*

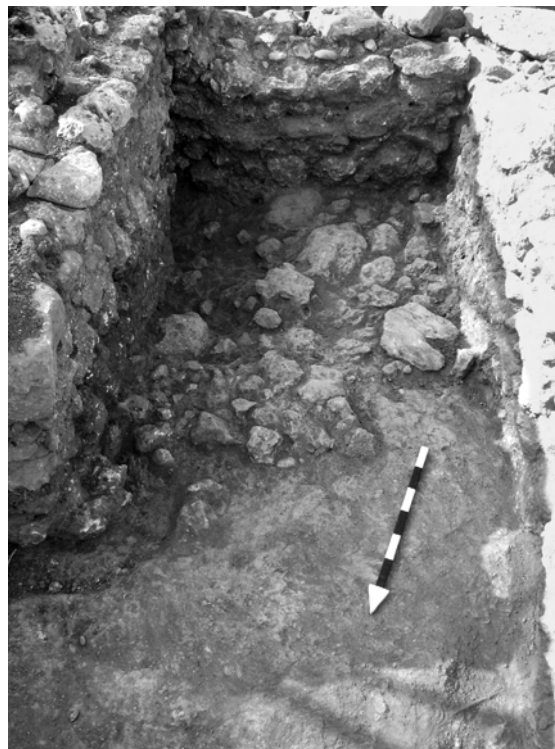
*Pl. 64. Interior of Room T2 with earlier rubble.*

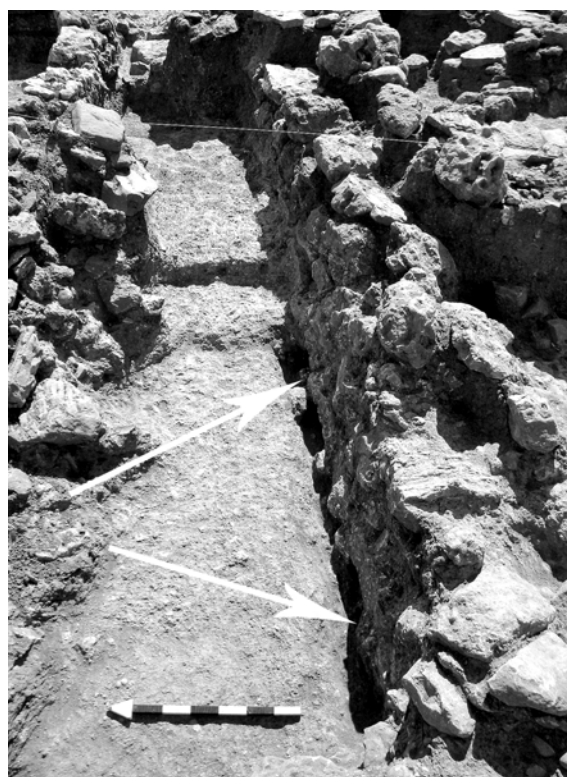
*Pl. 86. View of wall CT-032 from the West. The arrows indicate the foundation trench.*

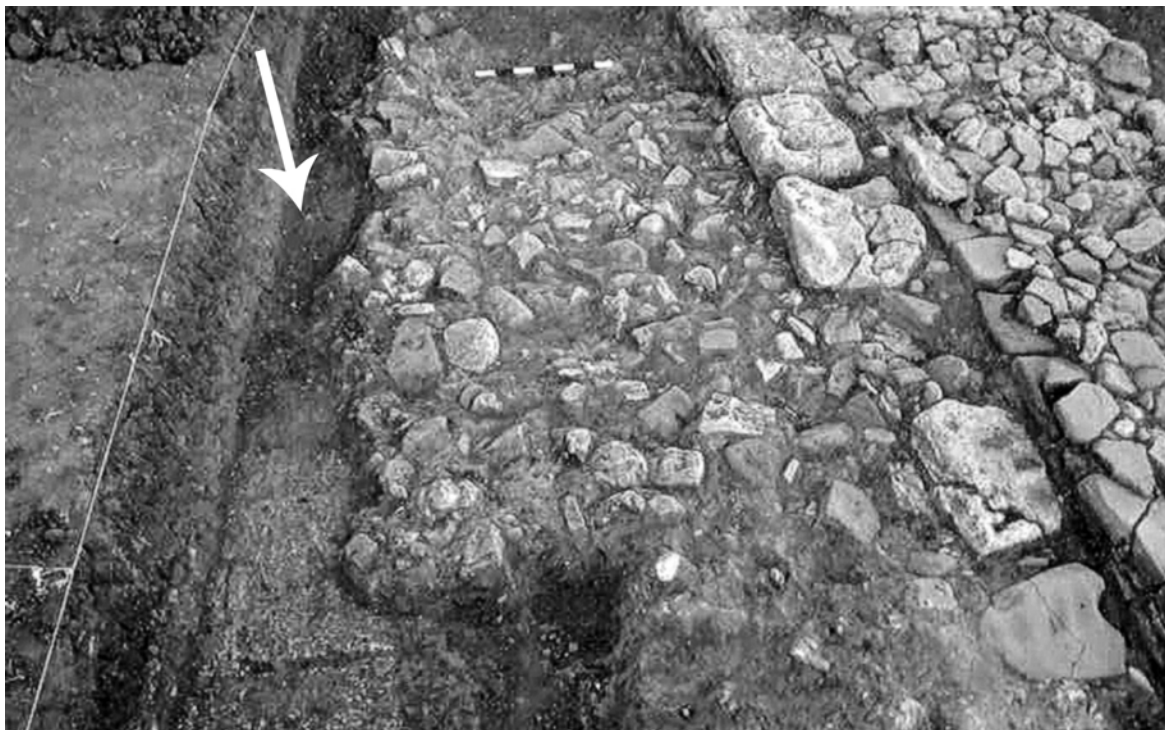
*Pl. 152. The south limit of the mudbrick destruction layer. The arrow shows the road.*
